Volkswagen > New Beetle > 1998 - 2005

70 - Interior trim

Instrument panel, removing and installing

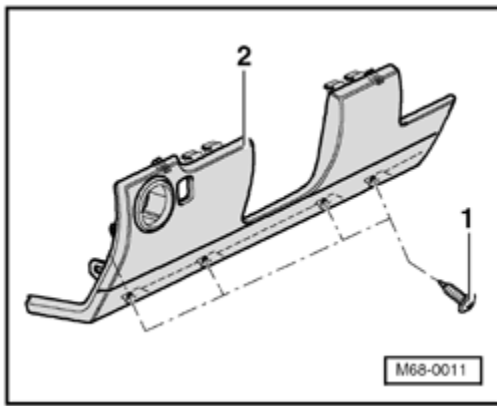
- Remove 4 screws -1-.
- Unclip trim -2- upward and remove from instrument panel.

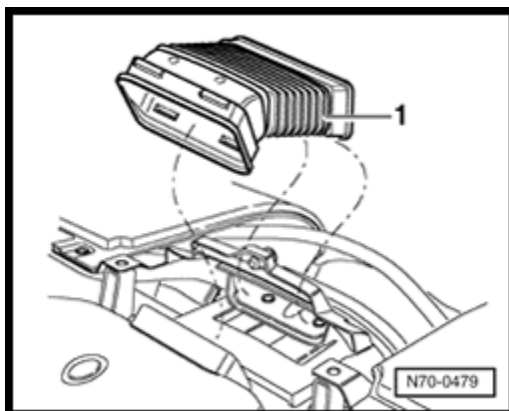
- Remove air duct -1- above center of instrument panel.
